SAMPLE INSPECTION REPORT

Property address: **514 9th Ave**
Glenside, PA 19038

Inspection date: **Sunday, November 13, 2016**

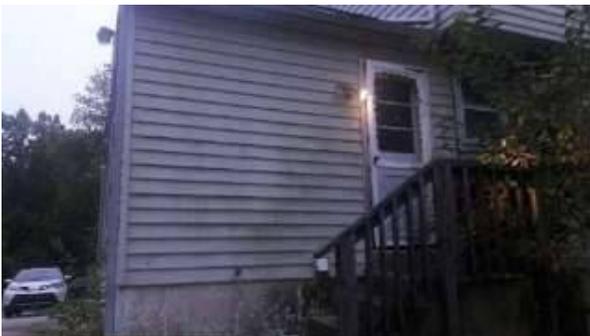
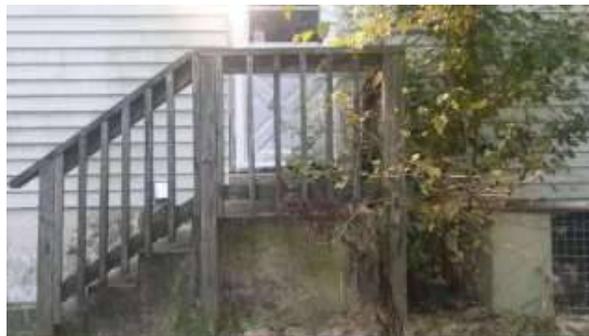
Handrails at the staircase leading from the rear entry of the home were not graspable and posed a fall hazard. Handrails should be 1 1/4 - 2 inches in diameter if round, or 2 5/8 inches or less in width if flat. Recommend that a qualified carpenter install graspable handrails or modify existing handrails per standard building practices.

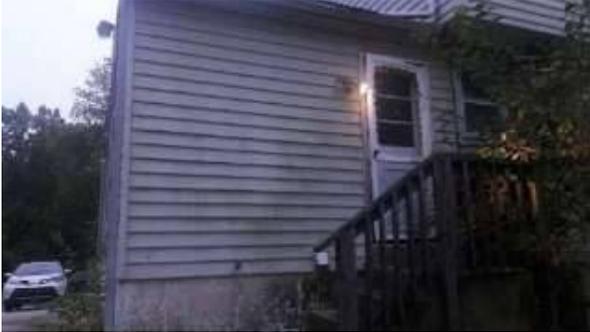
Photo 4-1

Aluminum Siding appeared to be in good condition, however at the rear of the building, rain related staining was observed. This was due to a clogged gutter above it. Recommended cleaning by an exterior contractor or handyman is advised. Siding could benefit from power washing.

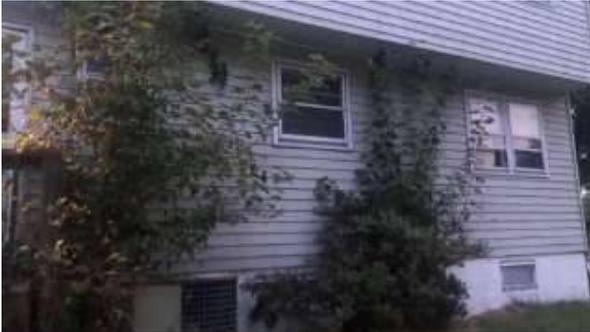
Photo 5-1

Vegetation such as trees, shrubs and/or vines was in contact with or close to the building exterior. Vegetation can serve as a pathway for wood-destroying insects and can retain moisture against the exterior after it rains. This is a conducive condition for wood-destroying organisms. Recommend pruning, moving or removing vegetation as necessary to maintain at least 6 inches of space between it and the building exterior. A 1-foot clearance is better.

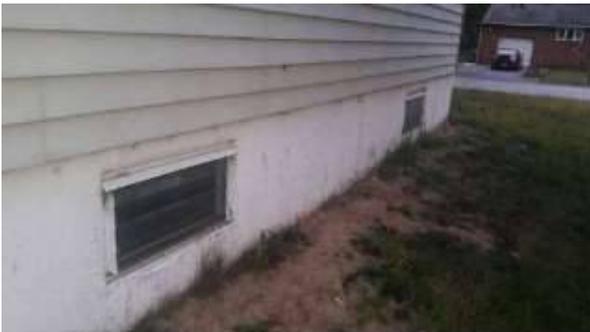
Photo 6-1

Paint on the exterior of the foundation appeared to be flaking. This is a cosmetic issue, however the surface would benefit from fresh coat of paint by a qualified painter.

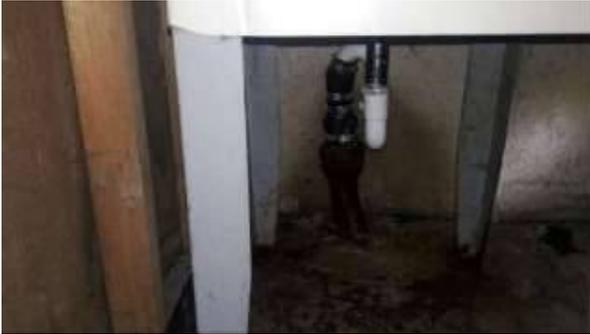
Photo 7-1

Wash basin in basement was found to have a leaking drain assembly, and a black residue discovered inside the wash basin might indicate a slow drainage when the washer discharges into the basin. This might cause property damage if not corrected. Further evaluation by a qualified plumber is recommended.

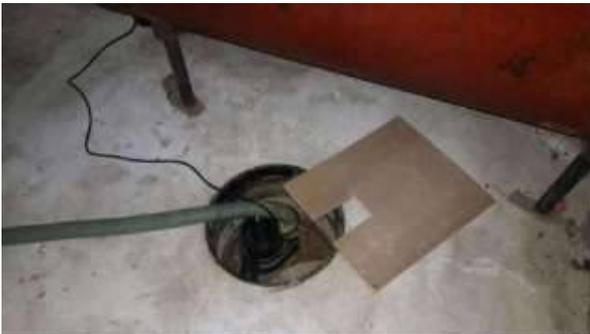
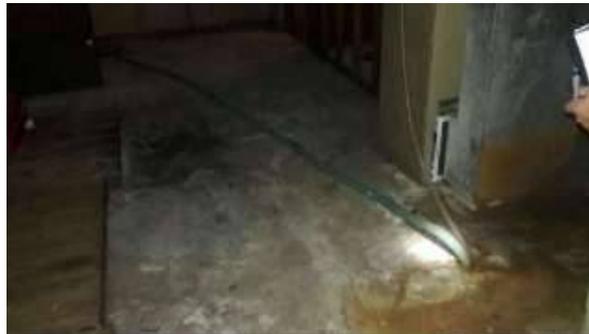
Sump pump was found to be inadequate and installed outside of common installation practice. The pump's discharge line was inserted into a hole in the basement floor. This is not a correct installation and can be a possible flood hazard and can lead to extensive property damage for the basement if water seeps up from the hole into the basement during times of heavy rain or an increase in the water table due to prolonged rain. Further evaluation by a qualified plumber is highly recommended.

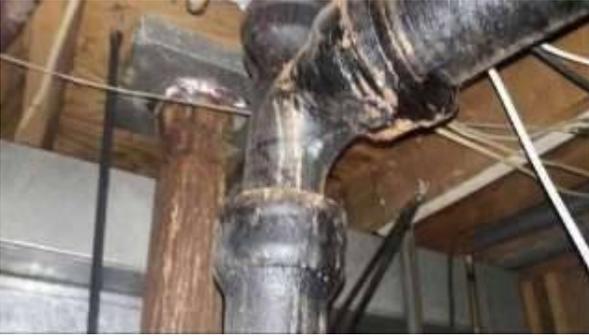
Photo 9-1

Possible fecal residue found on stack pipe in utility area. This might indicate a leak that might increase in size causing a possible health hazard and property damage if not corrected. Further evaluation by a qualified plumber is recommended.

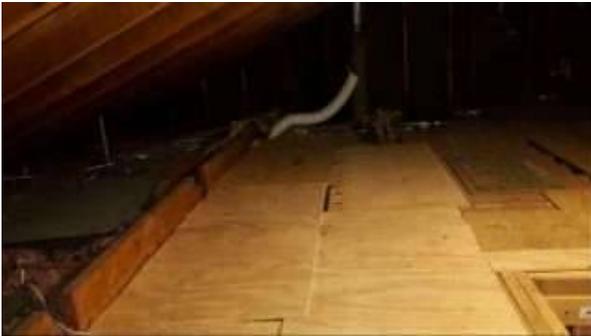
Photo 15-1

One or more exhaust fan ducts in the attic were not attached to a vent hood or cap. As a result, conditioned air will enter the attic when the fan is operated. Ducts terminating near an attic vent but without a dedicated vent hood or cap will likely blow conditioned air back into the attic. This can result in excessive moisture in the attic. Recommend that a qualified contractor repair per standard building practices, so exhaust fan ducts are permanently fastened to vent hoods or caps.

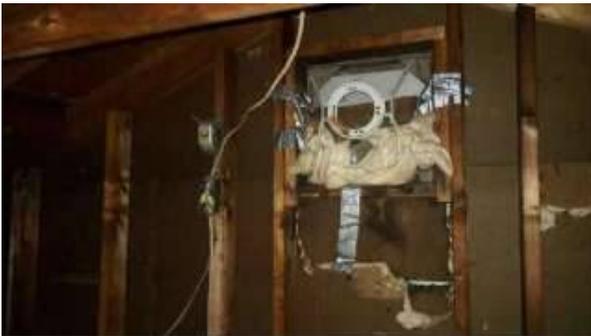
Photo 16-1

16) The electric ventilation fan was observed to be broken with tape and other materials stuffed around it. A further evaluation by a qualified electrician is recommended.

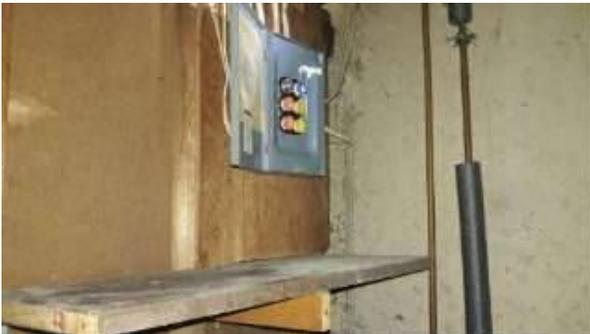
Photo 17-1

Panel(s) #C used screw-in fuses for the over-current protection devices. Fuses are prone to tampering and over-fusing, which can damage wiring and cause fire hazards. Insurance companies may deny coverage for homes with fused panels. Modern panels use circuit breakers for over-current protection devices, which can be reset easily after tripping rather than needing to replace fuses. Modern panels also offer more flexibility for new, safer protective technologies like ground fault circuit interrupters (GFCIs) and arc fault circuit interrupters (AFCIs). Consult with a qualified electrician about replacement options for fused panels, and about other system upgrades as necessary.

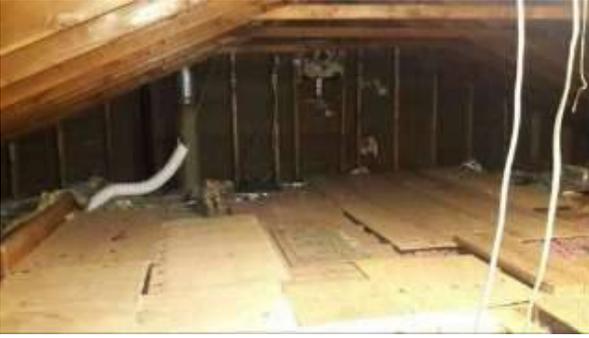
Photo 18-1

Non-metallic sheathed wiring was loose, unsupported, or inadequately supported at one or more locations. Such wiring should be trimmed to length if necessary and attached to runners or to solid backing with fasteners at intervals of 4 1/2 feet or less. Fasteners should be installed within 12 inches of all enclosures. Recommend that a qualified electrician repair per standard building practices.

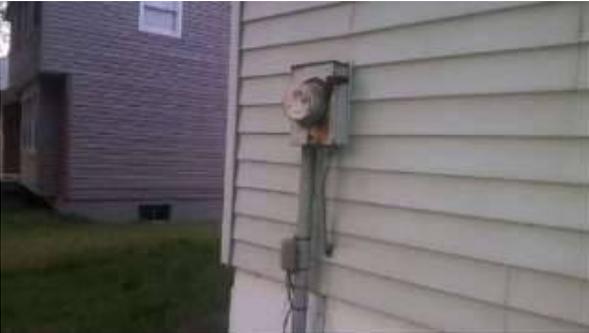
Photo 20-1

20) Service box on the exterior of home was observed to be rusted, suggesting water may have entered the enclosure. A further evaluation by a qualified electrician is recommended.

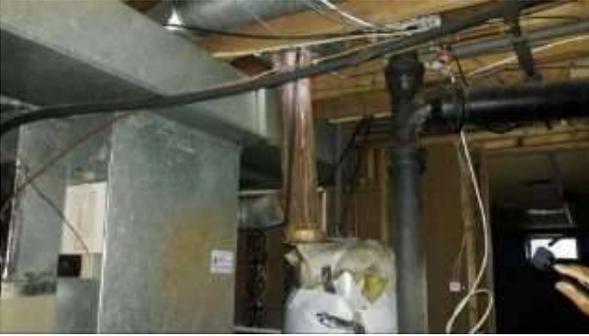
Photo 29-1

Wiring for the water heater's power supply was exposed and subject to damage. Standard building practices call for non-metallic sheathed wiring to be protected with BX armored conduit to prevent damage. This is a potential safety hazard for shock. Recommend that a qualified contractor repair per standard building practices.

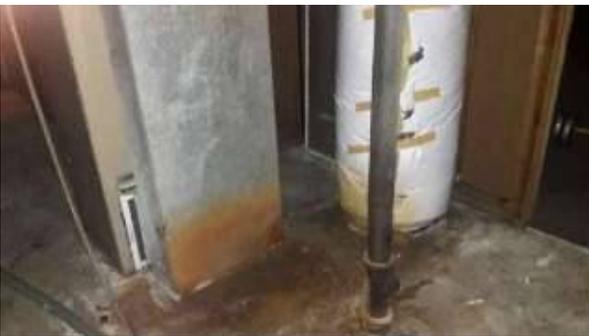
Photo 33-1

33) Water heater was wrapped in an insulating blanket. Water heaters are not required by common practice to be wrapped in an insulating blanket. This will not improve performance significantly enough to save on energy consumption. As it was wrapped in an insulating blanket at the time of inspection, a proper assessment of its age, brand, and approximation of its service life was not able to be done. Rust on the floor next to it could also indicate a possible leak. An evaluation by a qualified plumber is recommended.

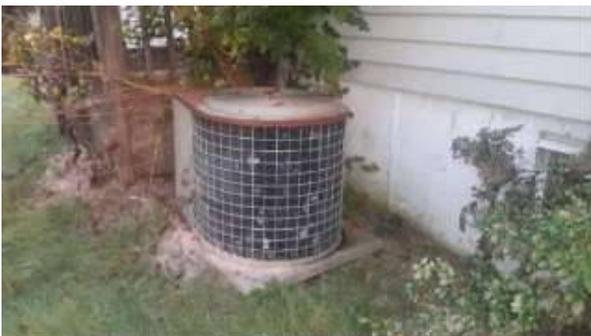
Photo 40-1

Vegetation such as trees, shrubs and/or vines were too close to the heat pump or air conditioning condensing unit. There should be at least 12 inches of clearance on all sides and at least 4-6 feet above. Inadequate clearance around and above can result in reduced efficiency, increased energy costs and/or damage to equipment. Recommend pruning and/or removing vegetation as necessary.

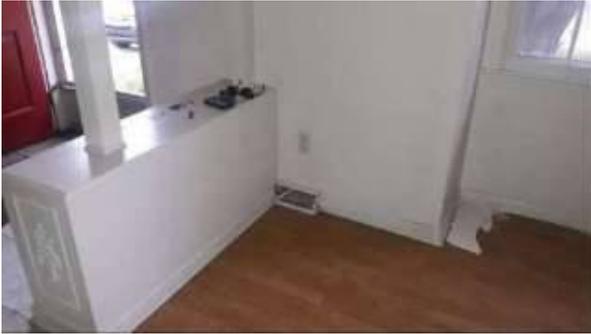
Photo 43-1

43) In the living room, an observation was made where a knee wall had been built in front of a floor register, blocking half of it. It is recommended that the issue needs a further evaluation by a qualified carpenter and an HVAC contractor.

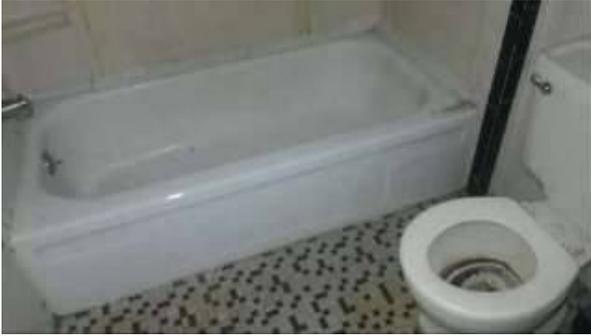
Photo 44-1

Bathtub surround was not done according to common building practice. It was observed to be a tile surround with a vinyl tub surround glued on top of it. It is possible that there is a leak where the vinyl surround meet the tub as there is painted duct tape placed at the meeting point. It is advised that a qualified tile installer or handyman evaluate the situation.

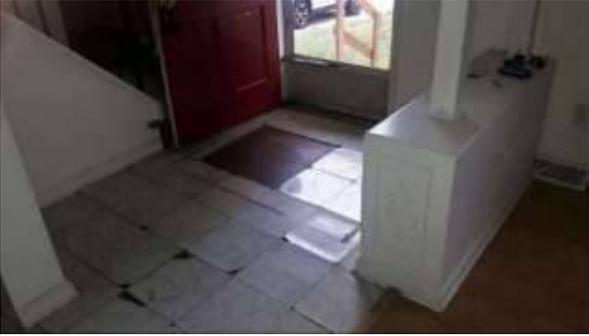
Photo 54-1

Vinyl, linoleum or marmoleum flooring in one or more areas was damaged, deteriorated, loose and/or curling. If in a wet area, water can damage the sub-floor as a result. Recommend that a qualified contractor replace or repair flooring as necessary.

This was observed in the front foyer. Replacement of the floor by a qualified tile installer or handyman is recommended.
